# NASA TECH BRIEF

## Cracks in Glass Electrical Connector Headers Removed by Dry Blasting with Fine Abrasive

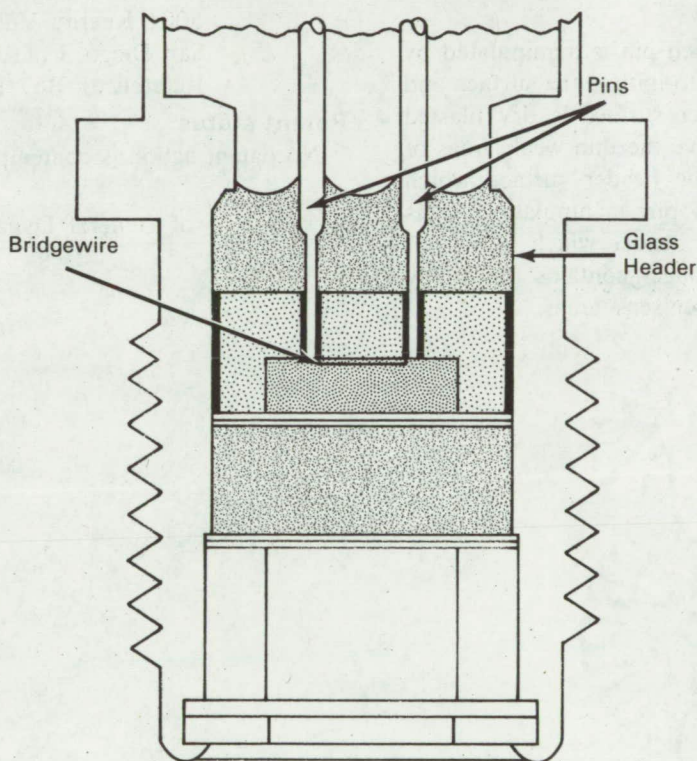
Explosive cartridges that have two or four pin bridgewire connections, designed to mate with female connectors, contain a glass header which insulates the pins from the case. These connectors typically exhibit cracking of the glass around the pins. If left alone, these cracks can propagate through the glass

header causing a pressure leakage failure of the insulator. Failure analyses have shown that most of these cracks, with few exceptions, are superficial and do not affect the integrity of the glass header. However, no satisfactory inspection criteria have been available to nondestructively distinguish between these and serious cracking. The only previous solution was to accept no cracks.

The major source of the cracking is the relatively minor flexing of the electrical pins after the header is fused. Slight pin movement, which occurs during operations such as cleaning, attachment of mating connectors for electrical tests, and installation of shorting devices, easily chips and cracks the thin glass meniscus around the pin. The cracks produced in these areas propagate for various distances away from the pins through the relatively high stressed surface area. Surface cracking or spalling may also occur independently of meniscus cracking due to the stress level on the surface.

Manipulate each pin, following the fusing operation, to initiate the surface and meniscus cracks. Then dry blast the header surface with a fine abrasive, such as a household cleanser.

To remove the cracks, each pin is manipulated by hand with a cylindrical tool to initiate the surface and meniscus cracks. The header surface is dry blasted with a fine abrasive to remove the thin weak areas of the meniscus cracks and the header surface which have been loosened by the pin manipulation. This treatment results in a glass header which is free of superficial cracks, and no longer contains the highly stressed surface or weak meniscus areas.
